# TEST REPORT

Cable Gland

AG-25

<b>TEST REPORT</b> <b>IEC60529</b> <b>Degrees of protection provided by enclosure(IP code)</b>	
Report Reference No.....	NST/GW131423-2-S
Compiled by.....	Cai Qinghong
Checked by.....	Zhu Ningfeng
Approved by.....	He Peng
Date of issue.....	2013-08-02
Signature: <i>Cai Qinghong</i> Signature: <i>Zhu Ningfeng</i> Signature: <i>He Peng</i>

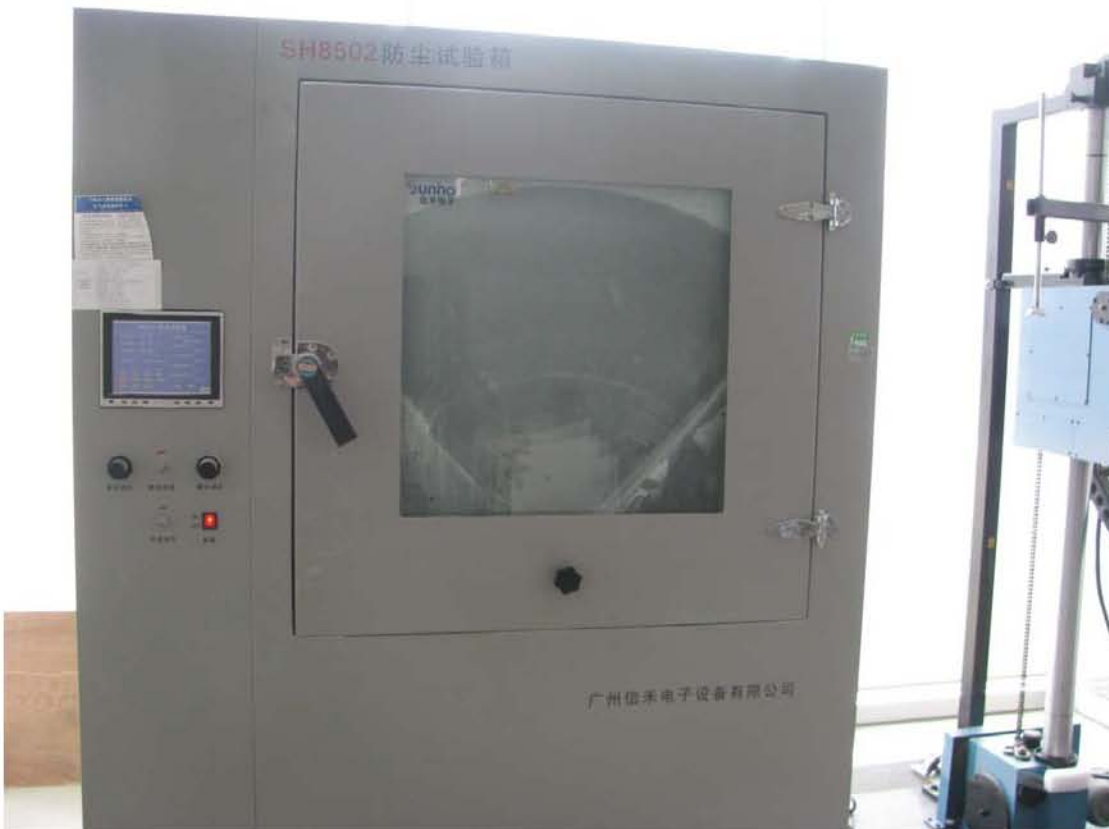
Photograph:

Standard:	IEC60529:2001
IP code:	IP68
Operating conditions:	IP6X: The object is freely suspended in the dust chamber, lasted 8 hours with the depression not exceed 2KPa, the pressure inside the enclosure is maintained below the surrounding atmospheric pressure by a vaccum pump.
Phenomenon( after the test):	IP6X: No deposit of dust is observable inside the sample at the end of the test. So the protection is satisfactory.

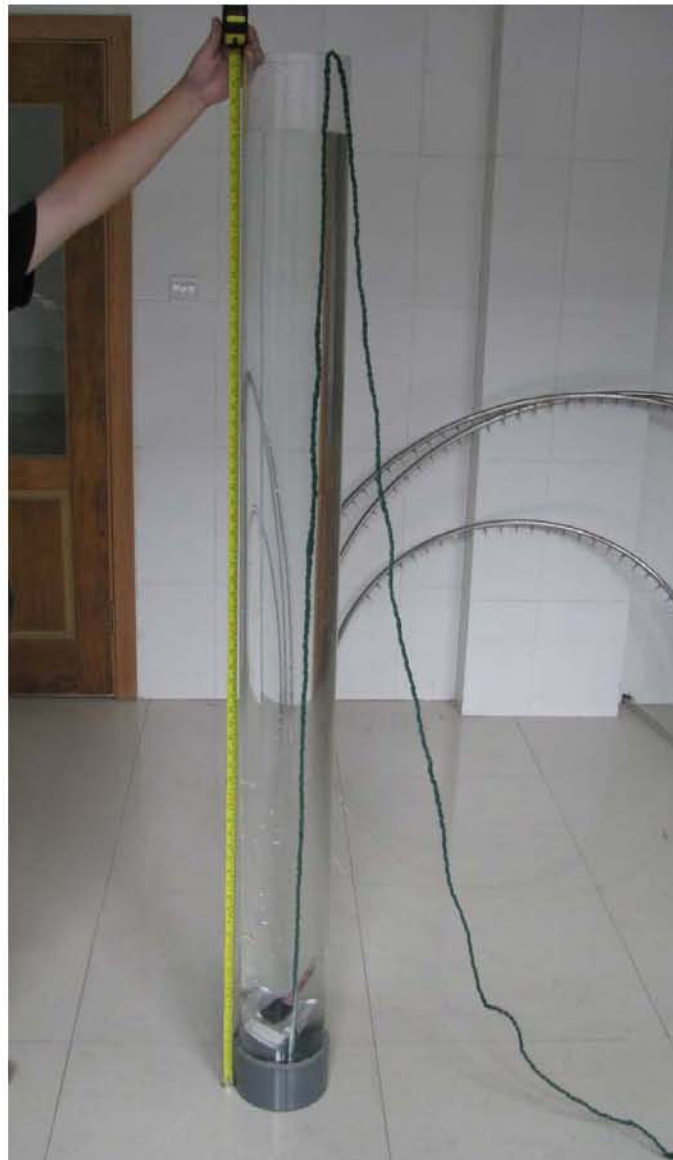
Operating conditions: IPX8: The lowest point of enclosures is located 1.5m below the surface of the water, the duration of the test is 35min; the water temperature does not differ from that of the equipment by more than 5K.

Phenomenon( after the test): IPX8: No water entered.

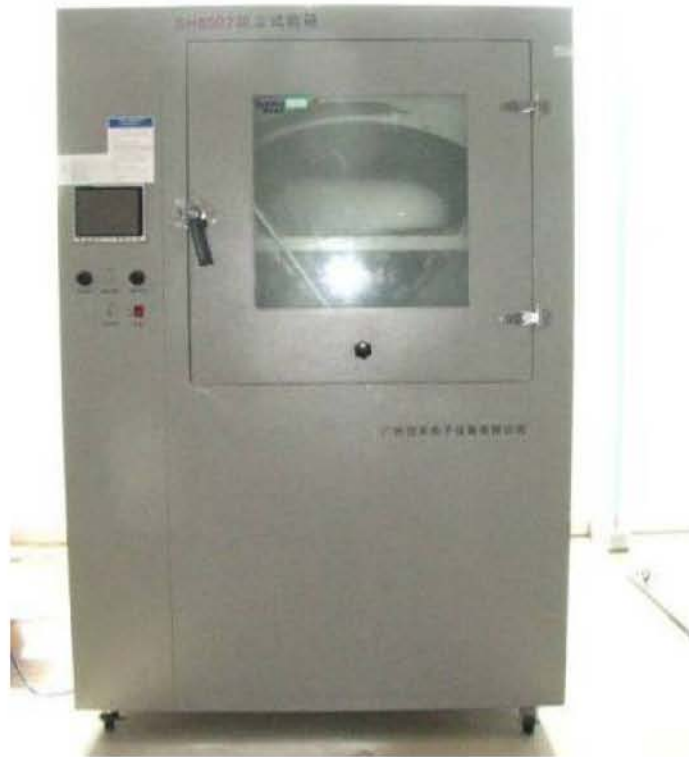
Fig.1 Dust chamber

- 1. Test equipments: Dust chamber (see Fig. 1), Immersiom test device(see Fig. 2),
- 2. Temperature: 22.5℃      Humidity: 70%RH
